**Flood Control Project Maintenance
Levee Inspections**

Fall 2018 Levee Maintenance Deficiency Summary Report

Sacramento River Basin

**Flood Control Project Maintenance
Levee Inspections****LMA District Cover Sheet
Fall 2018 Levee Inspection Results****Reclamation District No. 0349 Sutter Island**

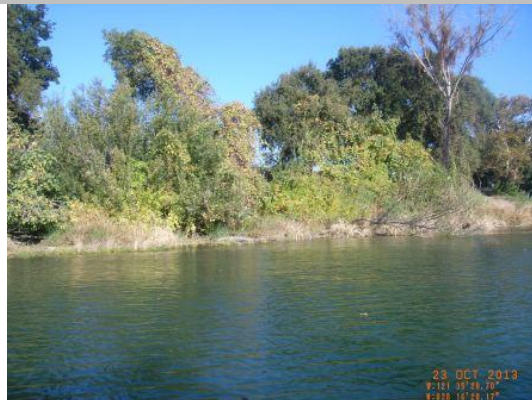
Photo 1 of 2 : FA_2018_RD0349_205_24_20181114_00008.jpg

LM Start	2.56	Rating **	A/W	Issue No.	24
LM End	2.69	Issue Type +	Ma	Location *	WS
Category	Supplemental			GPS Latitude/Longitude	
				Start	End
Item	2017 USACE Erosion Survey, DRAFT			38.273854 °	38.271998 °
				-121.588745 °	-121.589424 °
DWR ID	DWR_RD0349_02_f_2018_24				
Comment Code					
Inspector Comment					
2017 Site ID: STM 23.6 R					
Status: Eroding					
2017 Field Notes: Previously observed quarry stone at the downstream end is now gone. Significant erosion at upstream end. Fresh sedimentation on the downstream end.					
Site History: 2011 - Toe scour at the tidal zone. 2015 - New tree pop-out and minor new erosion. 2016 - New erosion at upstream end.

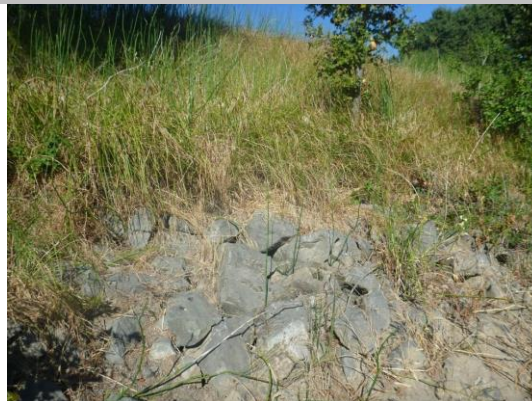
Photo 3 of 3 : FA_2018_RD0349_205_43_20180925_00028.jpg

LM Start	2.56	Rating **	A/W	Issue No.	43 (cont)
LM End	2.59	Issue Type +	Ma	Location *	
Category	Supplemental			GPS Latitude/Longitude	
				Start	End
Item	2017 Storm Damage			38.273769 °	38.273386 °
				-121.588742 °	-121.588672 °
DWR ID	DWR_RD0349_02_f _ 2017_43				
Comment Code					
Inspector Comment					
Levee Evaluation Comments					
Description:District Station 135+81 to 137+00, Sec. 13, T. 5 N. R. 3 E., M.D.M. Approximately 119 linear feet of sloughing exists due to scour along the water side toe of Steamboat Slough (Unit 2). The erosion area commences approximately 3/4 of the way down the slope from the levee crown and extends to the waterside toe. No rip rap is visible in this area.					
Site ID No:326					
Site Designation:LMA-153					
Repair Type: Erosion					
Rating:Area of Concern					
Field Date:7/28/2017					
Notes: no berm

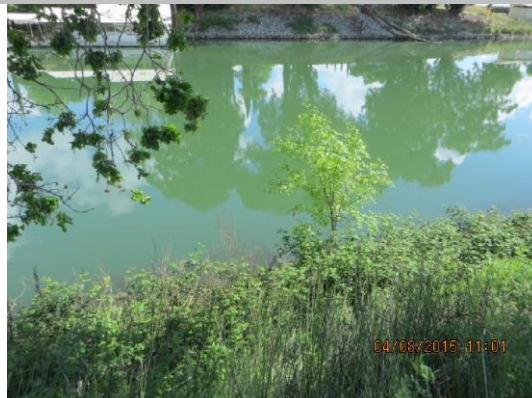
Photo 1 of 3 : UCIP_FA_2018_44328_73707.jpg

LM Start	2.93	Rating **	M	Issue No.	98	
LM End	2.93	Issue Type +	En	Location *		
Category	Supplemental			GPS Latitude/Longitude		
				Start	End	
Item	DWR UCIP Field Study			38.268674 °	38.268674 °	
				-121.589419 °	-121.589419 °	
DWR ID	24159					
Comment Code						
Inspector Comment						
FS_ID:44328						
DS_ID:24159						
EP_NO: N/A						
Repair Type: Non-Urgent						
Crossing Status: Found						
UCIP Comments: Pipe appears abandoned and should be done so properly.						
FIELD_STRUCT_DESC: *ABANDONED* 6-inch irrigation pipe of						
unknown material through the levee, 1.5 feet below the levee crown.						
[Additional Reference(s): DWR Levee Log, 2005. USACE Sacramento						
O&M Manual Unit No. 110, May 1959, revised 29 Dec 2016, (HLM 3.1)]						
FS Date: 4/8/2015

Pipe visible in water at WS toe.

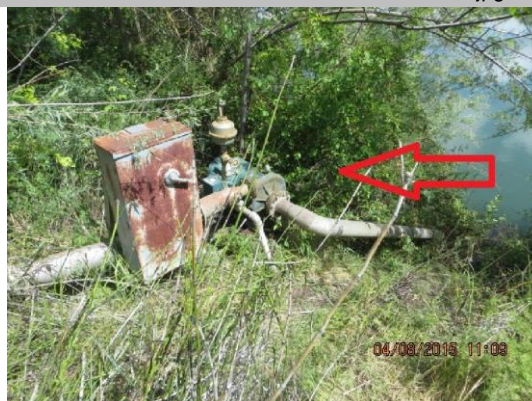
Photo 1 of 3 : UCIP_FA_2018_53344_73709.jpg

FS_ID:53344
DS_ID:24160
EP_NO: 655
Repair Type: Urgent
Crossing Status: Found
UCIP Comments: 7/24/2018 Same as last inspection. Dense vegetation on LS made inspection not accessible. WS pump and pipes, and electrical box, look operational. Contact owner to see if in operation; otherwise have abandoned properly. Crossing remains Urgent due to concern of internal levee integrity from corroded pipe (DWR UCIP - D. Sanoski).8/17/2016 Dense vegetation limits the inspector's visibility to inspect levee section along pipe alignment. Previous inspection indicates holes visible on pipe wall. Need to contact owner to notify that pipe needs to be abandoned properly per Title 23 requirements. (DWR UCIP - omagana)4/8/2015 Pipe visible on WS slope and appears to be open. Pipe needs to be properly abandoned or verified as having been done so properly. (DWR UCIP - omagana)
FIELD_STRUCT_DESC: *ABANDONED* 6-inch steel siphon irrigation pipe through the levee, 3.7 feet below the crown. Pump on concrete blocks on the waterside (WS) slope. 2-inch galvanized conduit is buried along side of the 6-inch pipe. PG&E service was installed on the landside (LS). (6-inch pipe authorized under Permit No. 5350, 1966 - Enver Salman; 6-inch pipe replaced previous 8-inch pipe authorized under Permit No. 655, 1935 - M. S. Salman) [Additional Reference(s): USACE San Joaquin O&M Manual Unit No. 110, May 1959, HLM 3.2, Drawing No. 50-4-3042; unable to confirm if 8-inch pipe is the same pipe listed in the USACE O&M manual as HLM 3.2].

Abandoned pipe visible on slope in vegetation behind new pipe on WS slope.

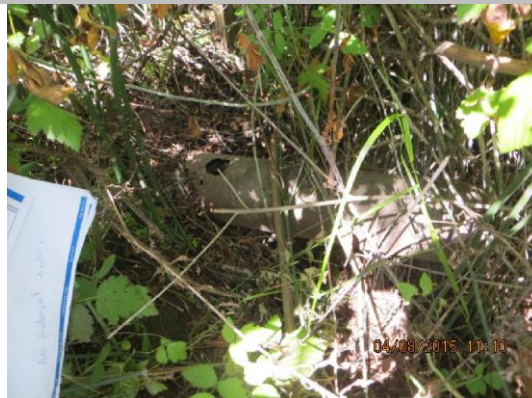
Photo 2 of 3 : UCIP_FA_2018_53344_73708.jpg

Abandoned pipe visible on slope in vegetation behind new pipe on WS slope.

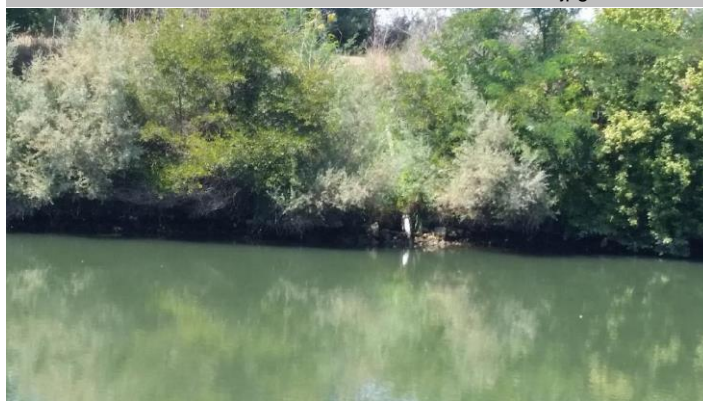
Photo 3 of 3 : UCIP_FA_2018_53344_75632.jpg

Pipe visible from opposite bank.

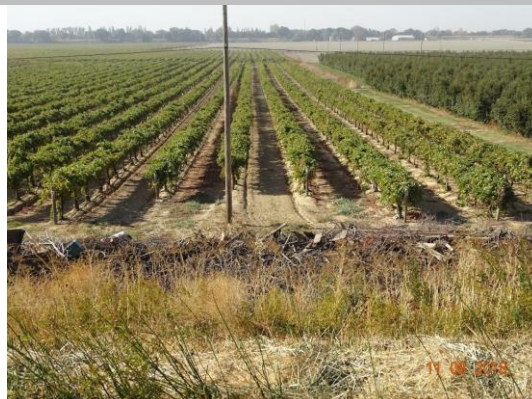
Photo 1 of 1 : FA_2018_RD0349_205_81_20181109_00107.jpg

LM Start	3.18	Rating **	M	Issue No.	81
LM End	3.18	Issue Type +	En	Location *	WS
Category	Earthen Levee			GPS Latitude/Longitude	
				Start	End
Item	Encroachments			38.265185 °	38.265185 °
				-121.588426 °	-121.588426 °
DWR ID	DWR_RD0349_02_s_2018_81				
Comment Code					
PR : Prunings					
Inspector Comment					
Remove prunings from the land side toe

View of prunings on the land side toe (November 2018).

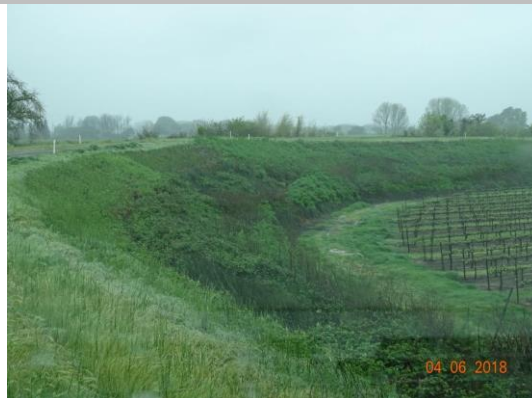
Photo 1 of 1 : FA_2018_RD0349_205_62_20180925_00039.jpg

LM Start	3.29	Rating **	M	Issue No.	62
LM End	3.60	Issue Type +	Ma	Location *	LS
Category	Earthen Levee			GPS Latitude/Longitude	
				Start	End
Item	Vegetation			38.263594 °	38.262449 °
				-121.588629 °	-121.593726 °
DWR ID	DWR_RD0349_02_f_2018_62				
Comment Code					
V9 : Keep the crown roadway free of vegetation.					
Inspector Comment					
Thick berry vines completely block inspection and access to toe.

Remove berry vines to allow inspection and access.

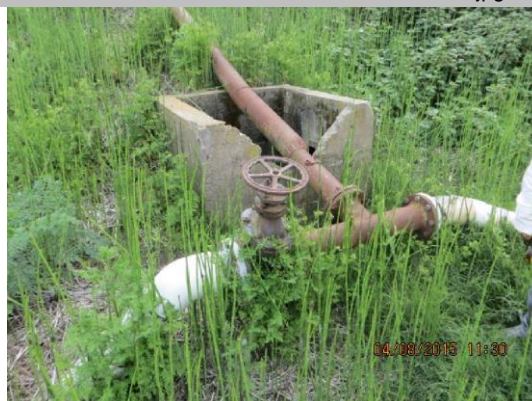
Photo 2 of 3 : UCIP_FA_2018_44333_73712.jpg

distribution box and pipe visible on LS toe.

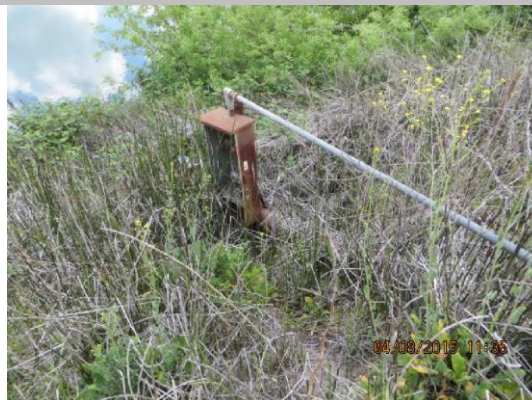
Photo 3 of 3 : UCIP_FA_2018_44333_73711.jpg

Pipe and electrical conduit visible on WS slope.

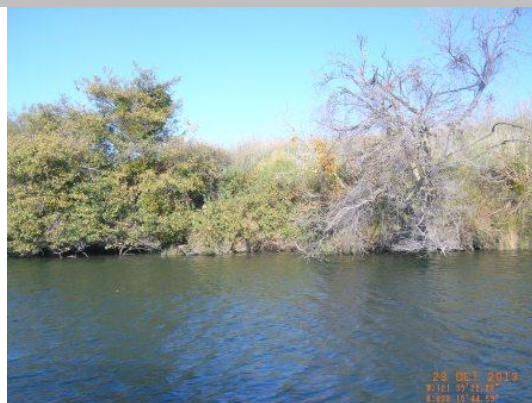
Photo 1 of 1 : FA_2018_RD0349_205_23_20181114_00007.jpg

LM Start	3.38	Rating **	M	Issue No.	23
LM End	3.49	Issue Type +	Ma	Location *	WS
Category	Supplemental			GPS Latitude/Longitude	
				Start	End
Item	2017 USACE Erosion Survey, DRAFT			38.262510 °	38.262533 °
				-121.589481 °	-121.591690 °
DWR ID	DWR_RD0349_02_f_2018_23				
Comment Code					
Inspector Comment					
2017 Site ID: STM 22.8 R					
Status: Eroding					
2017 Field Notes: No observed change.					
Site History: 2010 - Slumping sections on the lower bank, appears to be scouring around the trees. 2011 - Soil beach at toe.

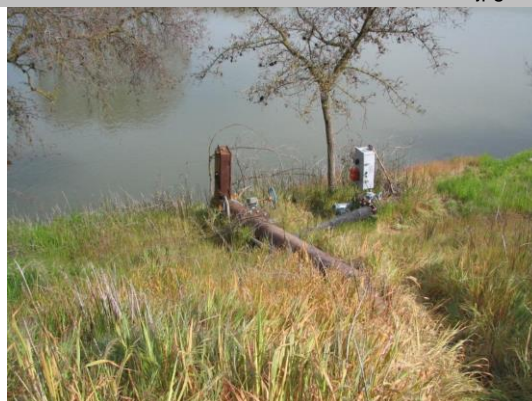
Photo 1 of 3 : UCIP_FA_2018_21612_36684.jpg

Comment Code					
Inspector Comment					
FS_ID:21612 DS_ID:24162 EP_NO: 8188 Repair Type: Non-Urgent Crossing Status: Found UCIP Comments: Dense vegetation limits the inspector's visibility to identify signs of pipe failure (leaks) along the landward slope. Recommend removing vegetation along pipe alignment to conduct proper inspection of structure and appurtenances. Unable to determine if crossing is in use. Note date on photos should be 3/18/09 not 7/26/08 camera metadata is incorrect. FIELD_STRUCT_DESC: 12-inch steel irrigation pipe and 1.25-inch electrical conduit through the levee, 5.0 feet below the levee crown. Steel cutoff wall around pipe at center of levee. Siphon breaker on shoulder. Pump and pump house on the waterside (WS). Service pole, discharge box and concrete standpipe at landside (LS) toe. (12-inch pipe authorized under Permit No. 8188, 1973 - E. Salman, 10-inch pipe removed) [Additional Reference(s): DWR Levee Log, 2005] FS Date: 3/18/2009

Overview of waterward side--2 crossings.

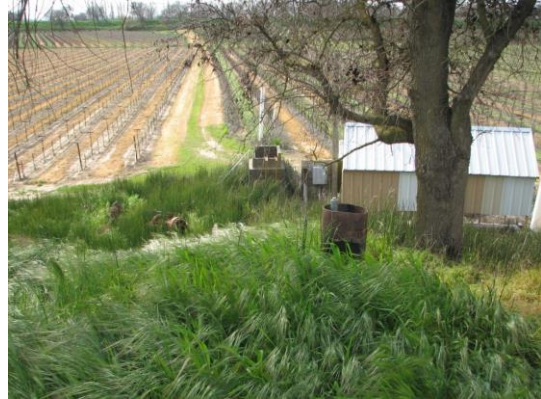
Photo 3 of 3 : UCIP_FA_2018_21612_36683.jpg

Comment Code						
Inspector Comment						
FS_ID:21612 DS_ID:24162 EP_NO: 8188 Repair Type: Non-Urgent Crossing Status: Found UCIP Comments: Dense vegetation limits the inspector's visibility to identify signs of pipe failure (leaks) along the landward slope. Recommend removing vegetation along pipe alignment to conduct proper inspection of structure and appurtenances. Unable to determine if crossing is in use. Note date on photos should be 3/18/09 not 7/26/08 camera metadata is incorrect. FIELD_STRUCT_DESC: 12-inch steel irrigation pipe and 1.25-inch electrical conduit through the levee, 5.0 feet below the levee crown. Steel cutoff wall around pipe at center of levee. Siphon breaker on shoulder. Pump and pump house on the waterside (WS). Service pole, discharge box and concrete standpipe at landside (LS) toe. (12-inch pipe authorized under Permit No. 8188, 1973 - E. Salman, 10-inch pipe removed) [Additional Reference(s): DWR Levee Log, 2005] FS Date: 3/18/2009

Overview of lanward side--appurtenances include distribution box, stand pipe, pump house, and control panel.

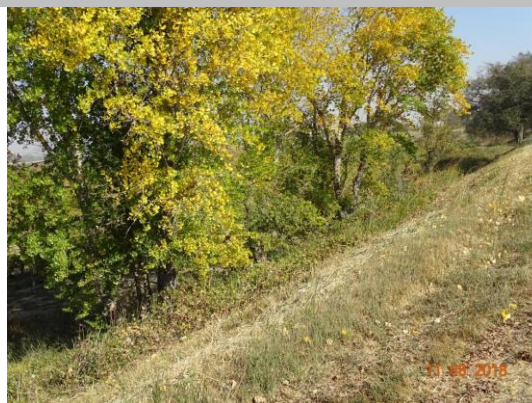
Photo 1 of 1 : FA_2018_RD0349_205_31_20181109_00100.jpg

LM Start	3.93	Rating **	M	Issue No.	31
LM End	4.31	Issue Type +	Ma	Location *	LS
Category	Earthen Levee			GPS Latitude/Longitude	
				Start	End
Item	Vegetation			38.258165 °	38.254680 °
				-121.595143 °	-121.599793 °
DWR ID	DWR_RD0349_02_f_2018_31				
Comment Code					
V2 : Remove the wild growth other than native grasses from the levee slopes.					
Inspector Comment					
Remove black berries and control vegetation all the way down to the land side toe

View looking downstream of vegetation part way down the land side slope (November 2018).

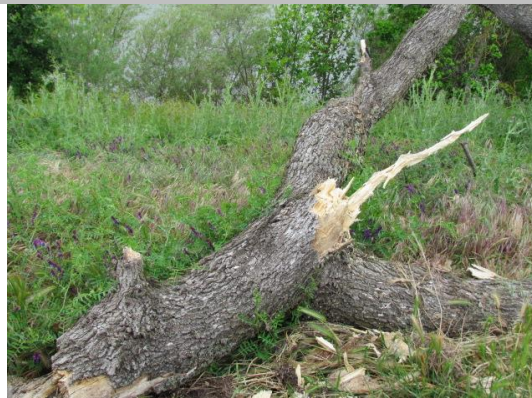
Photo 1 of 1 : FA_2018_RD0349_206_37_20180925_00005.jpg

LM Start	0.04	Rating **	M	Issue No.	37
LM End	0.04	Issue Type +	Ma	Location *	WS
Category	Earthen Levee			GPS Latitude/Longitude	
				Start	End
Item	Encroachments			38.255327°	38.255327°
				-121.600033°	-121.600033°
DWR ID	DWR_RD0349_03_f_2016_37				
Comment Code					
TR : Tree or limb					
Inspector Comment					
Dead tree on the waterside slope (large). This tree will fall and block access to the levee crown roadway. Remove the dead tree from the levee section.

RD 349 Unit 4 levee mile 0.04 Dead tree on the waterside shoulder and crown roadway.

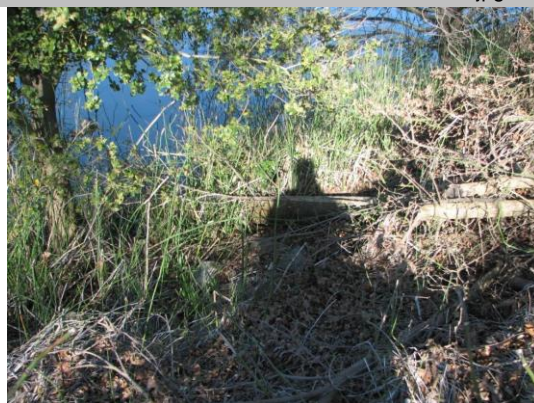
Photo 1 of 3 : UCIP_FA_2018_43442_36707.jpg

Comment Code						
Inspector Comment						
FS_ID:43442						
DS_ID:24163						
EP_NO: N/A						
Repair Type: Non-Urgent						
Crossing Status: Found						
UCIP Comments: Need to find owner and notify of pipe deterioration. Owner will need to replace or remove per CVFPB Title 23 requirements. Dense vegetation limits the inspector's visibility to identify signs of pipe failure (leaks) through the levee slopes. Recommend removing vegetation along pipe alignment to conduct proper inspection of structure and appurtenances. Note date on photos should be 3/18/09 not 7/26/08 camera metadata is incorrect.						
FIELD_STRUCT_DESC: 8-inch steel irrigation pipe through the levee, 2.4 feet below the crown. Pump and gate valve in a pump house at the landside (LS) toe. Concrete standpipe on LS. [Additional Reference(s): DWR Levee Log, 2005]						
FS Date: 3/19/2009

View of waterward side--portion of pipe exposed on slope.

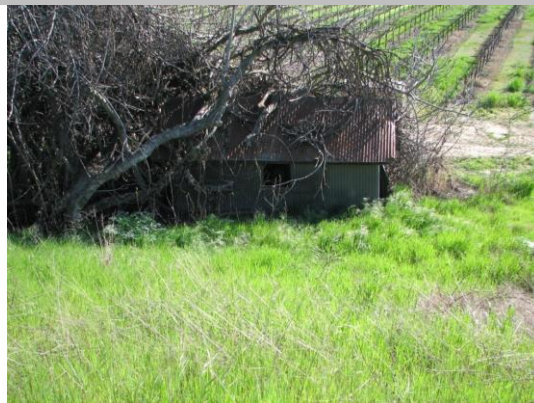
Photo 2 of 3 : UCIP_FA_2018_43442_36706.jpg

Pump house located at the landward toe.

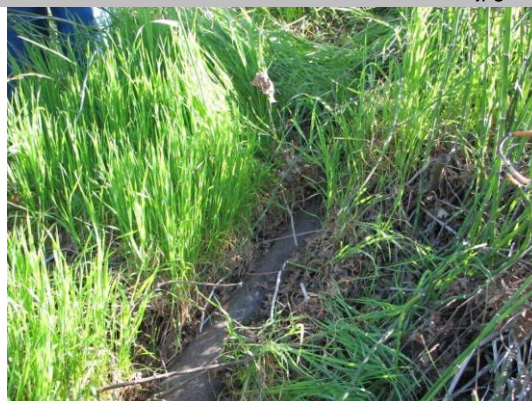
Photo 3 of 3 : UCIP_FA_2018_43442_36704.jpg

Comment Code						
Inspector Comment						
FS_ID:43442						
DS_ID:24163						
EP_NO: N/A						
Repair Type: Non-Urgent						
Crossing Status: Found						
UCIP Comments: Need to find owner and notify of pipe deterioration.						
Owner will need to replace or remove per CVFPB Title 23 requirements.						
Dense vegetation limits the inspector's visibility to identify signs of pipe						
failure (leaks) through the levee slopes. Recommend removing						
vegetation along pipe alignment to conduct proper inspection of						
structure and appurtenances. Note date on photos should be 3/18/09						
not 7/26/08 camera metadata is incorrect.						
FIELD_STRUCT_DESC: 8-inch steel irrigation pipe through the levee,

Pipe covered by dense vegetation.

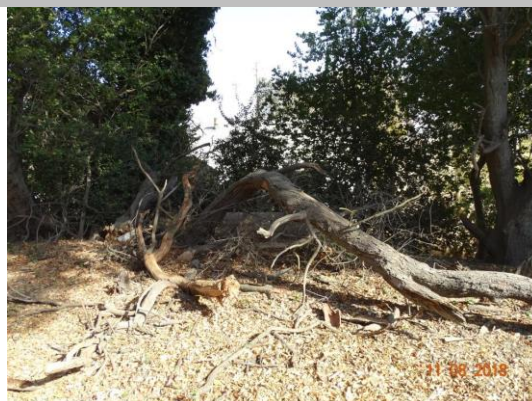
Photo 1 of 1 : FA_2018_RD0349_206_67_20181109_00095.jpg

LM Start	0.80	Rating **	M	Issue No.	67
LM End	0.80	Issue Type +	Ma	Location *	LS
Category	Earthen Levee			GPS Latitude/Longitude	
				Start	End
Item	Encroachments			38.266201 °	38.266201 °
				-121.601832 °	-121.601832 °
DWR ID	DWR_RD0349_03_s_2018_67				
Comment Code					
TR : Tree or limb					
Inspector Comment					
Trees and limbs on landside shoulder and slope need to be cleared out to allow inspection and access.

View of down tree on the land side shoulder (November 2018).

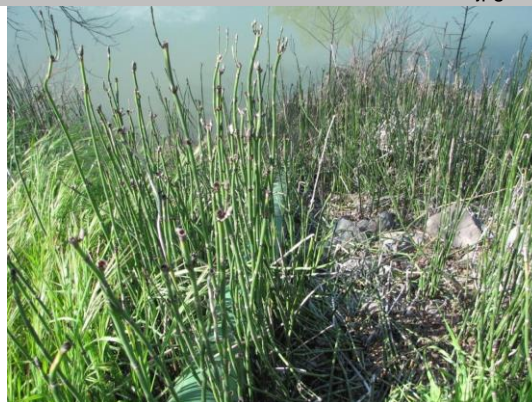
Photo 2 of 3 : UCIP_FA_2018_21673_36853.jpg

View of pipe crossing past pump station.

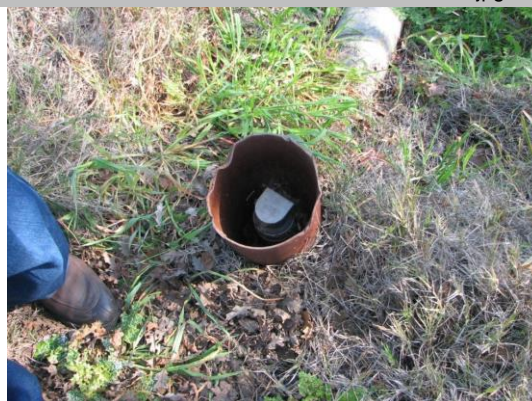
Photo 3 of 3 : UCIP_FA_2018_21673_36852.jpg

Comment Code						
Inspector Comment						
FS_ID:21673 DS_ID:24232 EP_NO: N/A Repair Type: Non-Urgent Crossing Status: Found UCIP Comments: No records were found during initial desk study--need to contact owner to obtain permit number authorizing work. Unable to determine if filter system is part of crossing appurtenances. If crossing is no longer used by owner, the owner will need to coordinate with DWR Inspector and CVFPB to remove crossing according to Title 23 requirements. Dense vegetation limits the inspector's visibility to identify signs of pipe failure (leaks) through the levee slopes. Recommend removing vegetation along pipe alignment to conduct proper inspection of structure and appurtenances. Note date on photos should be 3/18/09 not 7/26/08 camera metadata is incorrect. FIELD_STRUCT_DESC: 12-inch steel irrigation pipe through the levee, 2.0 feet below the levee crown. Pipe changes diameter, 10-inch along both shoulders and 8-inch diameter exit on waterside (WS). Pipe exposed along both slopes. Pump on WS. Filtration system and power pole on landside (LS). Rock revetment along WS slope. FS Date: 10/3/2013 9:42:00 AM

View of siphon breaker.

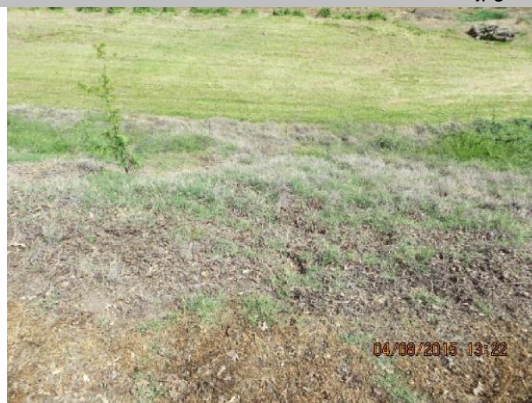
Photo 1 of 2 : UCIP_FA_2018_44335_73721.jpg

LM Start	1.17	Rating **	M	Issue No.	118	
LM End	1.17	Issue Type +	En	Location *		
Category	Supplemental			GPS Latitude/Longitude		
				Start		End
Item	DWR UCIP Field Study			38.271218 °		38.271218 °
				-121.603468 °		-121.603468 °
DWR ID	24166					
Comment Code						
Inspector Comment						
FS_ID:44335 DS_ID:24166 EP_NO: N/A Repair Type: Non-Urgent Crossing Status: Found UCIP Comments: Pipe abandoned and should be done so properly or verified as having been done so properly. FIELD_STRUCT_DESC: 6-inch irrigation pipe of unknown material through the levee, 4.5 feet below the levee crown. Pump and pump house no longer on the landside (LS) toe. [Additional Reference(s): DWR Levee Log, 2005. USACE Sacramento O&M Manual Unit No. 110, May 1959, revised 29 Dec 2016, (HLM 1.2)] FS Date: 4/9/2015

Pipe visible on LS slope.

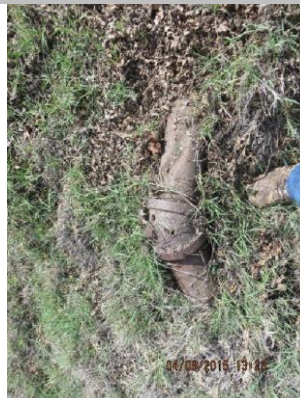
Photo 2 of 2 : UCIP_FA_2018_44335_73720.jpg

LM Start	1.17	Rating **	M	Issue No.	118 (cont)	
LM End	1.17	Issue Type +	En	Location *		
Category	Supplemental			GPS Latitude/Longitude		
				Start	End	
Item	DWR UCIP Field Study			38.271218 °	38.271218 °	
				-121.603468 °	-121.603468 °	
DWR ID	24166					
Comment Code						
Inspector Comment						
FS_ID:44335 DS_ID:24166 EP_NO: N/A Repair Type: Non-Urgent Crossing Status: Found UCIP Comments: Pipe abandoned and should be done so properly or verified as having been done so properly. FIELD_STRUCT_DESC: 6-inch irrigation pipe of unknown material through the levee, 4.5 feet below the levee crown. Pump and pump house no longer on the landside (LS) toe. [Additional Reference(s): DWR Levee Log, 2005. USACE Sacramento O&M Manual Unit No. 110, May 1959, revised 29 Dec 2016, (HLM 1.2)] FS Date: 4/9/2015

Pipe visible on LS slope.

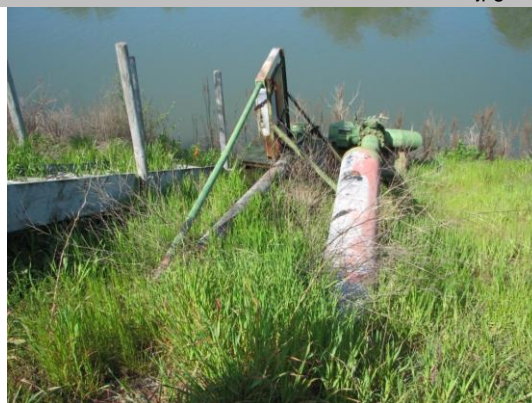
Photo 1 of 1 : UCIP_FA_2018_47043_36864.jpg

Comment Code					
Inspector Comment					
FS_ID:47043 DS_ID:24169 EP_NO: 11744 Repair Type: Non-Urgent Crossing Status: Found UCIP Comments: Dense vegetation limits the inspector's visibility to identify signs of pipe failure (leaks) through the levee slopes. Recommend removing vegetation along pipe alignment to conduct proper inspection of structure and appurtenances. Note date on photos should be 3/18/09 not 7/26/08 camera metadata is incorrect. FIELD_STRUCT_DESC: 1 of 2: 8-inch steel irrigation pipe through the levee, 3.7 feet below the crown. 8-inch pipe is reduced to 3-inch pipe on the waterside (WS). Steel cutoff wall around pipe at center of levee. Siphon breaker at landside (LS) shoulder. Siphon breaker at LS shoulder. Slant pump on WS. Discharge structure at LS toe. Rock revetment on WS slope. (8-inch pipe authorized under Permit No. 11744, 1976 - J. Wiedman, also appoved at different location is a 14-inch pipe through levee and 12-inch in the slopes) [Additional Reference(s): DWR Levee Log, 2005] FS Date: 3/19/2009

View of pipe, control panel, and stairs. 2 pipes go through levee 14-inch and 8-inch.

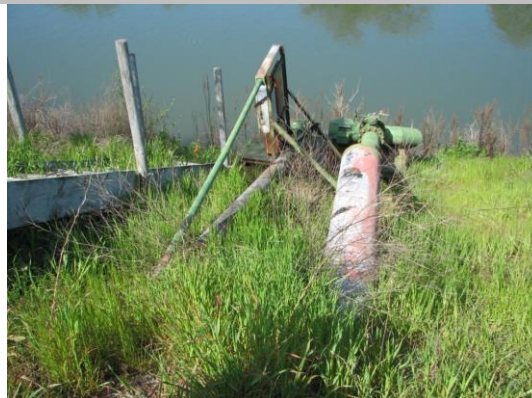
Photo 1 of 3 : UCIP_FA_2018_47042_36856.jpg

FS_ID:47042
DS_ID:24168
EP_NO: 11744
Repair Type: Non-Urgent
Crossing Status: Found
UCIP Comments: Dense vegetation limits the inspector's visibility to identify signs of pipe failure (leaks) through the levee slopes. Recommend removing vegetation along pipe alignment to conduct proper inspection of structure and appurtenances. Note date on photos should be 3/18/09 not 7/26/08 camera metadata is incorrect.
FIELD_STRUCT_DESC: 2 of 2: 14-inch steel irrigation pipe and 2-inch electric conduit through the levee, 4.4 feet below the levee crown. Pipe section on both levee slopes reduced to 12-inch steel pipe. Steel cutoff wall around pipe at center of levee. Siphon breaker at landside (LS) shoulder. Slant pump on waterside (WS) with staircase access. Discharge structure at LS toe. Rock revetment on WS slope. (14-inch pipe through levee and 12-inch in the slopes authorized under Permit No. 11744, 1976 - J. Wiedman, also approved at different location is a 8-inch pipe) [Additional Reference(s): DWR Levee Log, 2005]

Pump system located on waterward side.

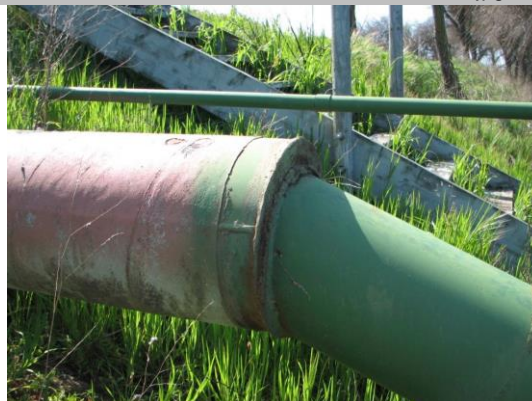
Photo 2 of 3 : UCIP_FA_2018_47042_36857.jpg

Pipe reduced from 14-inch to 10-inch and conduit through levee.

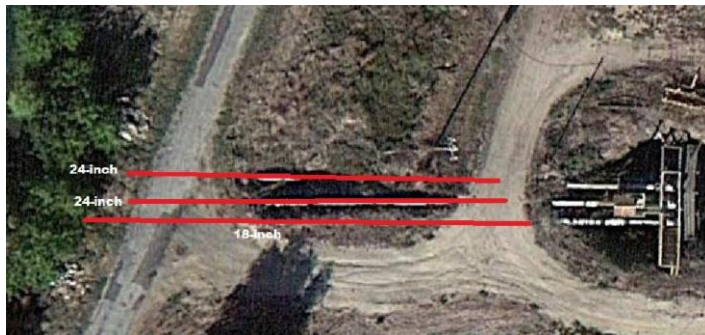
Photo 1 of 2 : UCIP_FA_2018_43446_36725.jpg

Comment Code					
Inspector Comment					
FS_ID:43446 DS_ID:24229 EP_NO: 2954 Repair Type: Non-Urgent Crossing Status: Found UCIP Comments: Dense vegetation limits the inspector's visibility to identify signs of pipe failure (leaks) through the levee slopes. Recommend removing vegetation along pipe alignment to conduct proper inspection of structure and appurtenances. Note date on photos should be 3/18/09 not 7/26/08 camera metadata is incorrect. FIELD_STRUCT_DESC: [R.D. No. 349 Drainage Pumping Plant] 1 of 3: 18-inch steel drainage pipe through the levee, 7.8 feet below the crown. Siphon breakers on waterside (WS) slope. Pumps on platform on landside (LS). [Additional Reference(s): DWR Levee Log, 2005. USACE Sacramento O&M Manual Unit No. 110, May 1959, revised 29 Dec 2016, (HLM 1.6)] FS Date: 3/19/2009

Aerial map showing alignment of 18-inch pipe.

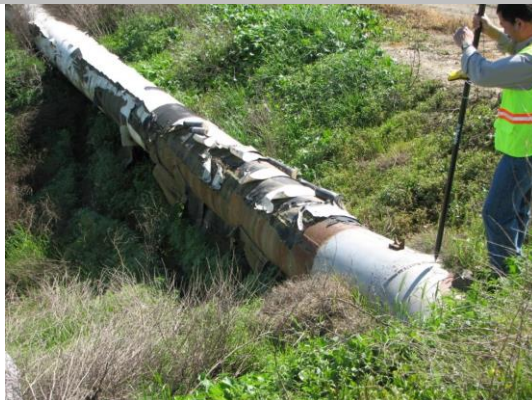
Photo 3 of 3 : UCIP_FA_2018_43445_36728.jpg

Comment Code						
Inspector Comment						
FS_ID:43445 DS_ID:24228 EP_NO: 2954 Repair Type: Non-Urgent Crossing Status: Found UCIP Comments: Dense vegetation limits the inspector's visibility to identify signs of pipe failure (leaks) along the slope. Recommend removing vegetation along pipe alignment to conduct proper inspection of structure and appurtenances. Note date on photos should be 3/18/09 not 7/26/08 camera metadata is incorrect. FIELD_STRUCT_DESC: [R.D. No. 349 Drainage Pumping Plant] 2 of 3: 24-inch steel drainage pipe through the levee, 7.8 feet below the crown. Siphon breakers on waterside (WS) slope. Pumps on platform on landside (LS). [Additional Reference(s): DWR Levee Log, 2005. USACE Sacramento O&M Manual Unit No. 110, May 1959, revised 29 Dec 2016, (HLM 1.6)] FS Date: 3/19/2009

Pipe is wrapped--unwrapped coating.

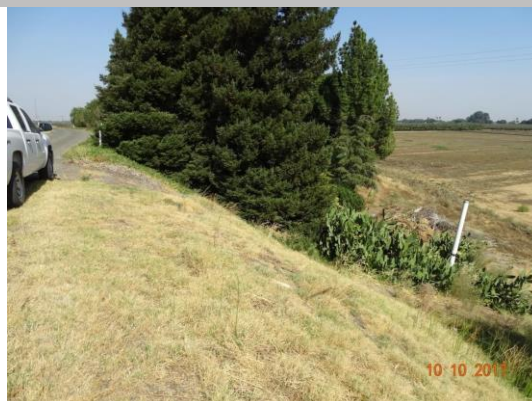
Photo 1 of 1 : FA_2018_RD0349_206_39_20180925_00006.jpg

LM Start	1.69	Rating **	U	Issue No.	39
LM End	1.76	Issue Type +	En	Location *	LS
Category	Earthen Levee			GPS Latitude/Longitude	
				Start	End
Item	Vegetation			38.278289 °	38.279339 °
				-121.600372 °	-121.600306 °
DWR ID	DWR_RD0349_03_f_2017_39				
Comment Code					
V6 : Landscaping					
Inspector Comment					
Remove cactus and trim and thin evergreens to allow insect and access.

Landscaping on landside at LM 1.67.

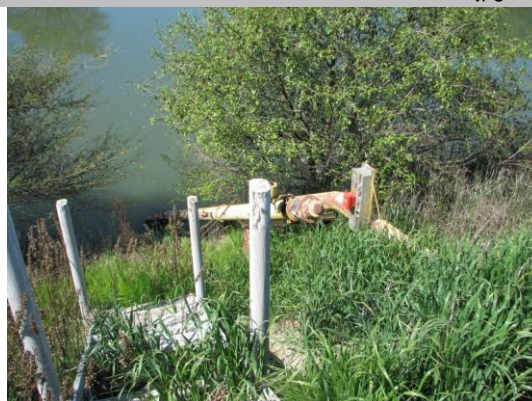
Photo 1 of 3 : UCIP_FA_2018_47045_36736.jpg

Comment Code					
Inspector Comment					
FS_ID:47045 DS_ID:24172 EP_NO: N/A Repair Type: Non-Urgent Crossing Status: Found UCIP Comments: Dense vegetation limits the inspector's visibility to identify signs of pipe failure (leaks) through the levee slopes. Recommend removing vegetation along pipe alignment to conduct proper inspection of structure and appurtenances. Note date on photos should be 3/18/09 not 7/26/08 camera metadata is incorrect. FIELD_STRUCT_DESC: 1 of 2: 12-inch irrigation pipe of unknown material and 2-inch electrical conduit through the levee, 8.0 feet below the levee crown. Siphon breaker in pipe riser on landside (LS) slope. Concrete standpipe at LS toe. Pump on waterside (WS) with stairway access. [Additional Reference(s): DWR Levee Log, 2005] FS Date: 3/19/2009

View of waterward side--pump, pipe, control panel, and stairway.

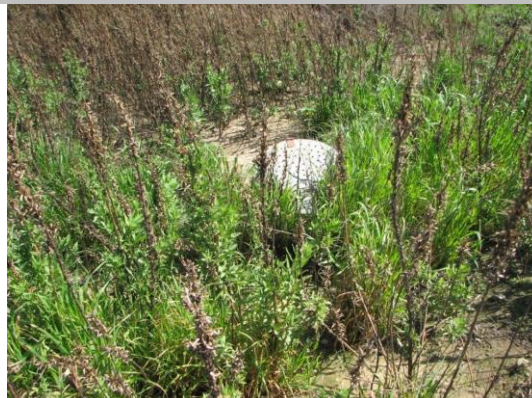
Photo 2 of 3 : UCIP_FA_2018_47045_36735.jpg

Comment Code						
Inspector Comment						
FS_ID:47045 DS_ID:24172 EP_NO: N/A Repair Type: Non-Urgent Crossing Status: Found UCIP Comments: Dense vegetation limits the inspector's visibility to identify signs of pipe failure (leaks) through the levee slopes. Recommend removing vegetation along pipe alignment to conduct proper inspection of structure and appurtenances. Note date on photos should be 3/18/09 not 7/26/08 camera metadata is incorrect. FIELD_STRUCT_DESC: 1 of 2: 12-inch irrigation pipe of unknown material and 2-inch electrical conduit through the levee, 8.0 feet below the levee crown. Siphon breaker in pipe riser on landside (LS) slope. Concrete standpipe at LS toe. Pump on waterside (WS) with stairway access. [Additional Reference(s): DWR Levee Log, 2005] FS Date: 3/19/2009

Stand pipe located on landward shoulder--pipe locked.

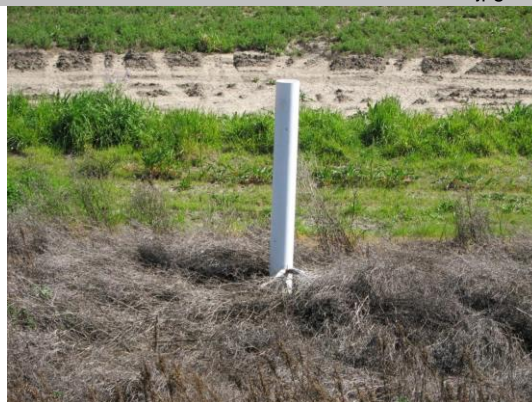
Photo 3 of 3 : UCIP_FA_2018_47045_36737.jpg

Tall thin stand pipe located on landward side--unable to find pipe.

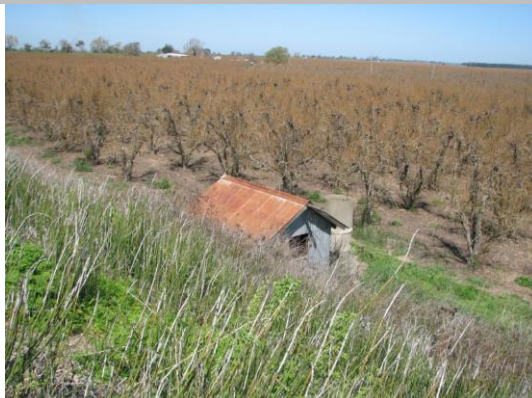
Photo 1 of 2 : UCIP_FA_2018_21634_36739.jpg

Comment Code						
Inspector Comment						
FS_ID:21634 DS_ID:24173 EP_NO: N/A Repair Type: Non-Urgent Crossing Status: Found UCIP Comments: Dense vegetation limits the inspector's visibility to identify signs of pipe failure (leaks) through the levee slopes. Recommend removing vegetation along pipe alignment to conduct proper inspection of structure and appurtenances. Note date on photos should be 3/18/09 not 7/26/08 camera metadata is incorrect. FIELD_STRUCT_DESC: 8-inch steel irrigation pipe through the levee, 6.7 feet below the levee crown. Pump in pump house and concrete standpipe located on the landside (LS) toe. [Additional Reference(s): DWR Levee Log, 2005. USACE Sacramento O&M Manual Unit No. 110, May 1959, revised 29 Dec 2016, (HLM 2.1)] FS Date: 3/19/2009

View of landward side--pump house and stand pipe.

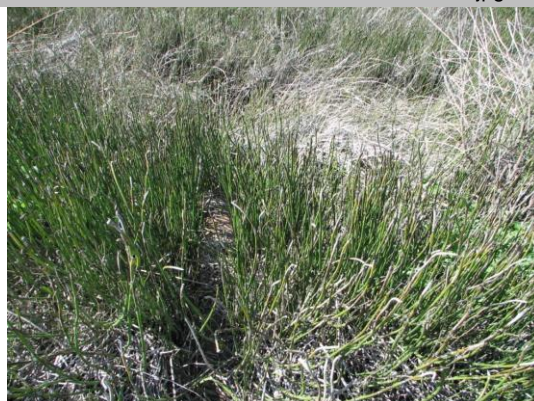
Photo 1 of 3 : UCIP_FA_2018_43423_36866.jpg

Comment Code					
Inspector Comment					
FS_ID:43423 DS_ID:24176 EP_NO: N/A Repair Type: Non-Urgent Crossing Status: Found UCIP Comments: Need to contact owner--If crossing is no longer used by owner, the owner will need to coordinate with DWR Inspector and CVFPB to remove crossing according to Title 23 requirements. Dense vegetation limits the inspector's visibility to identify signs of pipe failure (leaks) through the levee slopes. Recommend removing vegetation along pipe alignment to conduct proper inspection of structure and appurtenances. Note date on photos should be 3/18/09 not 7/26/08 camera metadata is incorrect. FIELD_STRUCT_DESC: *ABANDONED* 10-inch steel irrigation pipe through the levee, 8.2 feet below the levee crown. Pipe has plate welded on the waterside (WS) end. 3-inch galvanized pipe runs parallel to 10-inch pipe. Abandoned tank on WS slope. Distribution box and concrete standpipe at landside (LS) toe. [Additional Reference(s): DWR Levee Log, 2005. USACE Sacramento O&M Manual Unit No. 110, May 1959, revised 29 Dec 2016, (HLM 2.7)] FS Date: 3/19/2009

View of waterward side--dense vegetation covers slope.

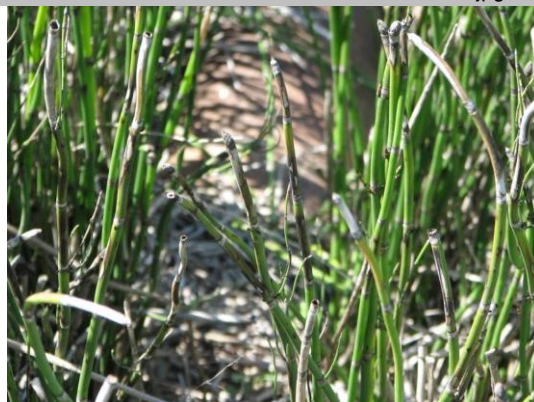
Photo 2 of 3 : UCIP_FA_2018_43423_36865.jpg

Pipe visible on waterward side.

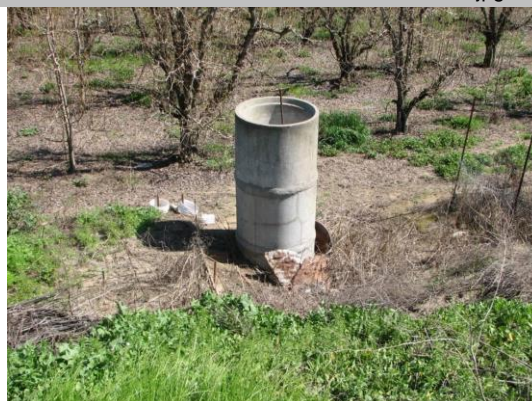
Photo 3 of 3 : UCIP_FA_2018_43423_36867.jpg

Comment Code						
Inspector Comment						
FS_ID:43423 DS_ID:24176 EP_NO: N/A Repair Type: Non-Urgent Crossing Status: Found UCIP Comments: Need to contact owner--If crossing is no longer used by owner, the owner will need to coordinate with DWR Inspector and CVFPB to remove crossing according to Title 23 requirements. Dense vegetation limits the inspector's visibility to identify signs of pipe failure (leaks) through the levee slopes. Recommend removing vegetation along pipe alignment to conduct proper inspection of structure and appurtenances. Note date on photos should be 3/18/09 not 7/26/08 camera metadata is incorrect. FIELD_STRUCT_DESC: *ABANDONED* 10-inch steel irrigation pipe through the levee, 8.2 feet below the levee crown. Pipe has plate welded on the waterside (WS) end. 3-inch galvanized pipe runs parallel to 10-inch pipe. Abandoned tank on WS slope. Distribution box and concrete standpipe at landside (LS) toe. [Additional Reference(s): DWR Levee Log, 2005. USACE Sacramento O&M Manual Unit No. 110, May 1959, revised 29 Dec 2016, (HLM 2.7)] FS Date: 3/19/2009

Stand pipe located on landward toe.

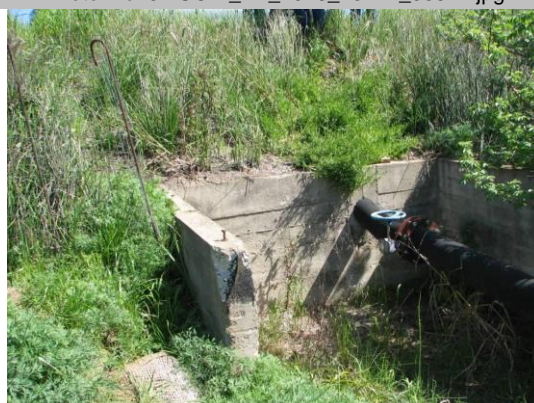
Photo 2 of 3 : UCIP_FA_2018_43424_36871.jpg

Comment Code						
Inspector Comment						
FS_ID:43424						
DS_ID:24177						
EP_NO: N/A						
Repair Type: Non-Urgent						
Crossing Status: Found						
UCIP Comments: 2007 Erosion Repair Site location?--Need to contact owner to determine if crossing is still in use. If crossing is no longer used by owner, the owner will need to coordinate with DWR Inspector and CVFPB to remove crossing according to Title 23 requirements. Dense vegetation limits the inspector's visibility to identify signs of pipe failure (leaks) through the levee slopes. Recommend removing vegetation along pipe alignment to conduct proper inspection of structure and appurtenances. Note date on photos should be 3/18/09 not 7/26/08 camera metadata is incorrect.						
FIELD_STRUCT_DESC: *ABANDONED* 8-inch steel irrigation pipe through the levee, 8.7 feet below the crown. Headwall and gate valve on the landside (LS). (re-installation of 8-inch pipe on waterside (WS) authorized under Permit No. 18345, 2012 - Wheeler and Thomas LLC)

Waterward side--appears to be an erosion repair site. New pipe on waterward side and damaged pipe on landward side.

View of waterward side--headwall, pipe, and gate valve.

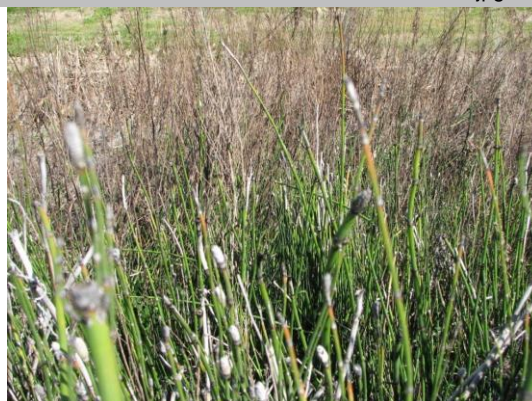
Photo 3 of 3 : UCIP_FA_2018_43424_36868.jpg

Comment Code						
Inspector Comment						
FS_ID:43424						
DS_ID:24177						
EP_NO: N/A						
Repair Type: Non-Urgent						
Crossing Status: Found						
UCIP Comments: 2007 Erosion Repair Site location?--Need to contact owner to determine if crossing is still in use. If crossing is no longer used by owner, the owner will need to coordinate with DWR Inspector and CVFPB to remove crossing according to Title 23 requirements. Dense vegetation limits the inspector's visibility to identify signs of pipe failure (leaks) through the levee slopes. Recommend removing vegetation along pipe alignment to conduct proper inspection of structure and appurtenances. Note date on photos should be 3/18/09 not 7/26/08 camera metadata is incorrect.						
FIELD_STRUCT_DESC: *ABANDONED* 8-inch steel irrigation pipe through the levee, 8.7 feet below the crown. Headwall and gate valve on the landside (LS). (re-installation of 8-inch pipe on waterside (WS) authorized under Permit No. 18345, 2012 - Wheeler and Thomas LLC)

View of landward side--dense vegetation on slope limits inspection.

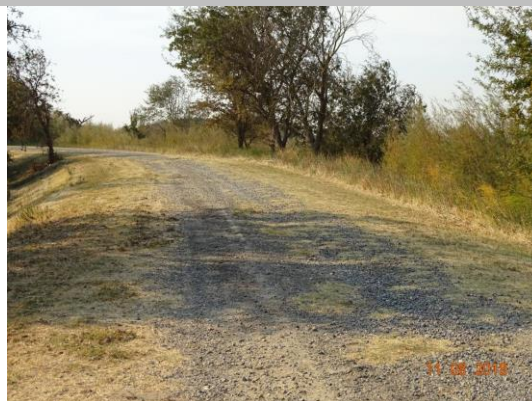
Photo 1 of 1 : FA_2018_RD0349_206_100_20181109_00087.jpg

LM Start	2.97	Rating **	M	Issue No.	100
LM End	2.97	Issue Type +	Ma	Location *	WS
Category	Earthen Levee			GPS Latitude/Longitude	
				Start	End
Item	Vegetation			38.295445 °	38.295445 °
				-121.604692 °	-121.604692 °
DWR ID	DWR_RD0349_03_f_2018_100				
Comment Code					
V1 : Control annual grass and weeds on the levee slopes and easements.					
Inspector Comment

View looking downstream at vegetation off the water side shoulder (November 2018).

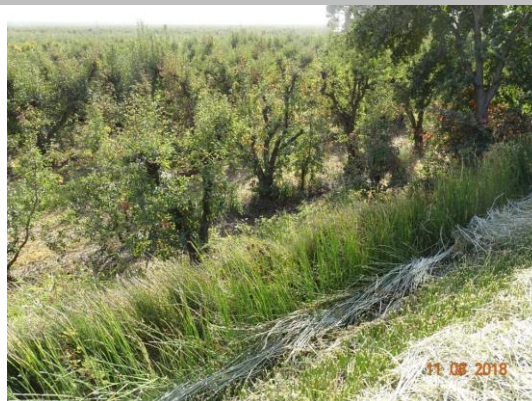
Photo 1 of 1 : FA_2018_RD0349_206_105_20181109_00091.jpg

LM Start	3.04	Rating **	M	Issue No.	105
LM End	3.15	Issue Type +	En	Location *	LS
Category	Earthen Levee			GPS Latitude/Longitude	
				Start	End
Item	Encroachments			38.296388 °	38.297773 °
				-121.604558 °	-121.603635 °
DWR ID	DWR_RD0349_03_f_2018_105				
Comment Code					
CR : Crops					
Inspector Comment					
Orchard trees at land side toe

View looking slightly downstream at orchard trees on the land side toe (November 2018).

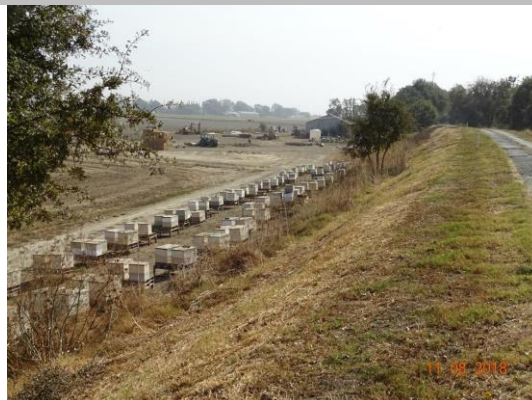
Photo 1 of 1 : FA_2018_RD0349_206_106_20181109_00092.jpg

LM Start	3.15	Rating **	M	Issue No.	106
LM End	3.15	Issue Type +	Ma	Location *	LS
Category	Earthen Levee			GPS Latitude/Longitude	
				Start	End
Item	Vegetation			38.297773 °	38.297773 °
				-121.603635 °	-121.603635 °
DWR ID	DWR_RD0349_03_f_2018_106				
Comment Code					
V1 : Control annual grass and weeds on the levee slopes and easements.					
Inspector Comment					
Remove vegetation all the way down the land side slope

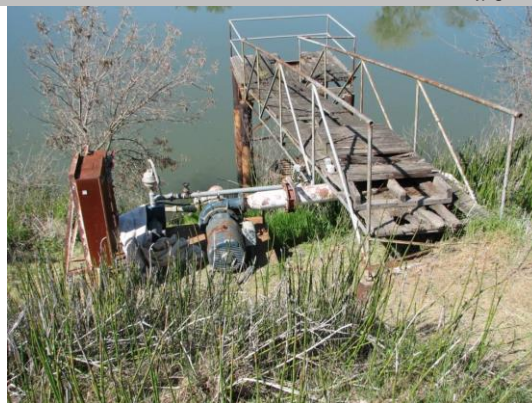
Photo 1 of 3 : UCIP_FA_2018_44389_36873.jpg

LM Start	3.34	Rating **	M	Issue No.	129	
LM End	3.34	Issue Type +	En	Location *		
Category	Supplemental			GPS Latitude/Longitude		
				Start	End	
Item	DWR UCIP Field Study			38.299703 °	38.299703 °	
				-121.601112 °	-121.601112 °	
DWR ID	24179					
Comment Code						
Inspector Comment						
FS_ID:44389 DS_ID:24179 EP_NO: N/A Repair Type: Non-Urgent Crossing Status: Found UCIP Comments: Crossing altered--need to contact owner to obtain permit number authorizing work. Dense vegetation limits the inspector's visibility to identify signs of pipe failure (leaks) along the slope. Recommend removing vegetation along pipe alignment to conduct proper inspection of structure and appurtenances. Note date on photos should be 3/18/09 not 7/26/08 camera metadata is incorrect. FIELD_STRUCT_DESC: *DELETE* FS Date: 4/9/2015

View of waterward side--pump, control panel, pipe, and walkway.

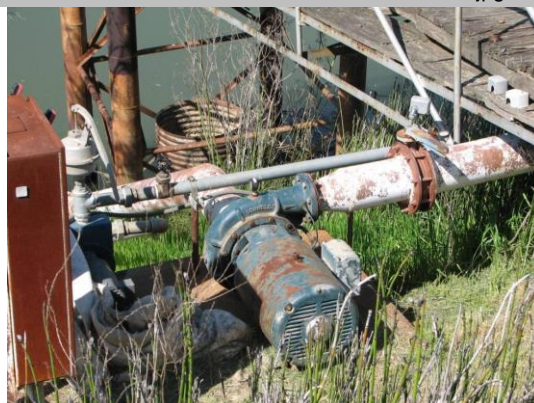
Photo 2 of 3 : UCIP_FA_2018_44389_36875.jpg

Corrugated metal riser located on waterward toe.

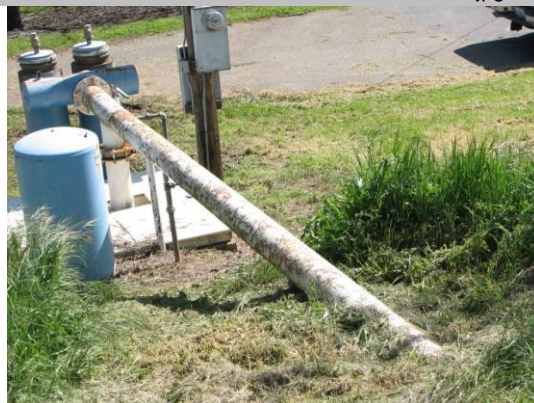
Photo 3 of 3 : UCIP_FA_2018_44389_36874.jpg

View of landward side.

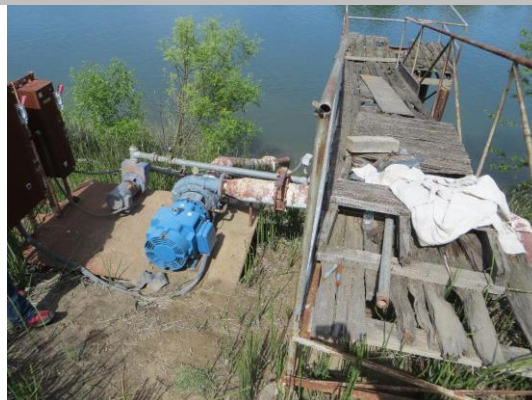
Photo 2 of 2 : UCIP_FA_2018_44390_73746.jpg

Pump, electrical panel, butterfly valve, and walkway on WS slope.

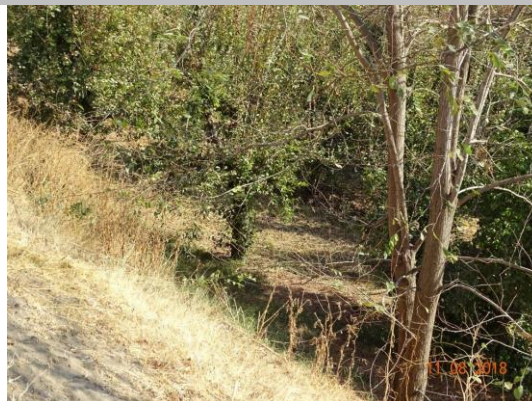
Photo 1 of 1 : FA_2018_RD0349_206_103_20181109_00090.jpg

LM Start	3.40	Rating **	M	Issue No.	103
LM End	3.57	Issue Type +	En	Location *	LS
Category	Earthen Levee			GPS Latitude/Longitude	
				Start	End
Item	Encroachments			38.300347 °	38.302612 °
				-121.600275 °	-121.599198 °
DWR ID	DWR_RD0349_03_f_2018_103				
Comment Code					
CR : Crops					
Inspector Comment					
Orchard trees at land side toe

View looking slightly upstream at orchard trees on the land side toe (November 2018).

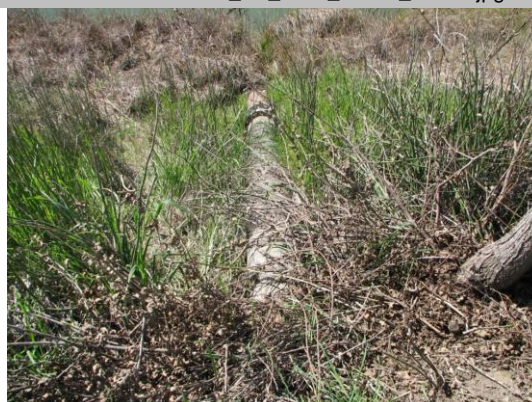
Photo 2 of 2 : UCIP_FA_2018_43455_36782.jpg

View of waterward side.

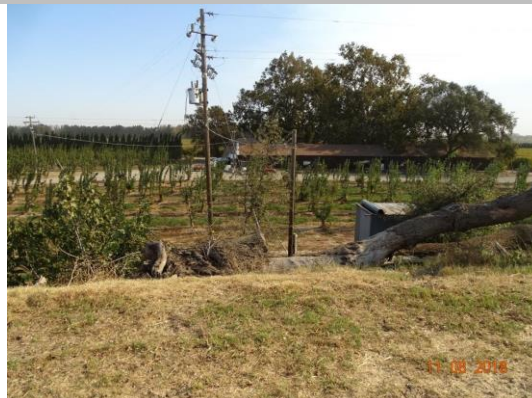
Photo 1 of 1 : FA_2018_RD0349_206_75_20181109_00089.jpg

LM Start	3.96	Rating **	M	Issue No.	75
LM End	3.96	Issue Type +	En	Location *	LS
Category	Earthen Levee			GPS Latitude/Longitude	
				Start	End
Item	Encroachments			38.307532°	38.307532°
				-121.596888°	-121.596888°
DWR ID	DWR_RD0349_03_s_2018_75				
Comment Code					
TR : Tree or limb					
Inspector Comment					
Remove fallen tree on landside slope.

View of fallen tree on the land side slope (November 2018).

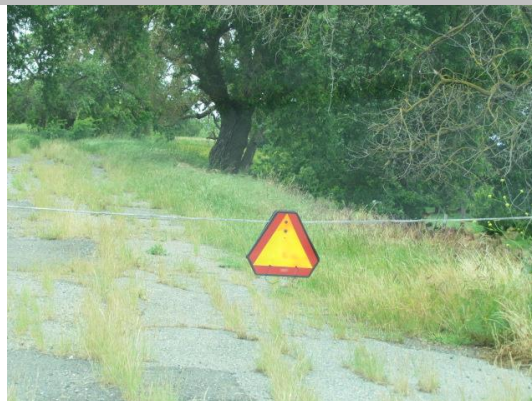
Photo 1 of 1 : FA_2018_RD0349_206_25_20180925_00003.jpg

LM Start	3.99	Rating **	U	Issue No.	25
LM End	3.99	Issue Type +	En	Location *	LS
Category	Earthen Levee			GPS Latitude/Longitude	
				Start	End
Item	Encroachments			38.307997 °	38.307997 °
				-121.597039 °	-121.597039 °
DWR ID	DWR_RD0349_03_s_2012_25				
Comment Code					
FE : Fence					
Inspector Comment					
Unauthorized cable gate crossing levee. Cable gates crossing the levee crown have been prohibited. This encroachment should be removed.

Cable crossings has been banned. They are unauthorized.

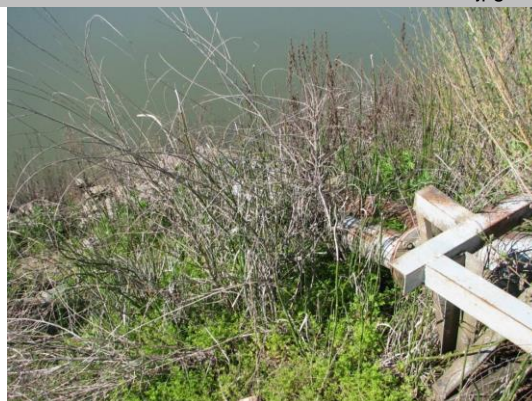
Photo 1 of 3 : UCIP_FA_2018_43459_36796.jpg

Comment Code						
Inspector Comment						
FS_ID:43459						
DS_ID:24185						
EP_NO: N/A						
Repair Type: Non-Urgent						
Crossing Status: Found						
UCIP Comments: No connection present--need to contact owner to determine if owner plans to use. If crossing is no longer in use owner will need to coordinate with DWR inspector and CVFPB to remove according to Title 23 requirements. Recommend removing vegetation along pipe alignment. Note date on photos should be 3/18/09 not 7/26/08 camera metadata is incorrect.						
FIELD_STRUCT_DESC: *ABANDONED* 10-inch steel irrigation pipe and 2-inch electrical conduit through the levee, both 2.8 feet below the levee crown. Abandoned pumps and gate valve on the waterside (WS) slope. Service pole on the landside (LS) slope. Concrete headwall on LS. [Additional Reference(s): DWR Levee Log, 2005. USACE Sacramento O&M Manual Unit No. 110, May 1959, revised 29 Dec 2016, (HLM 4.8)]

Waterward side--pipe visible through dense vegetation.

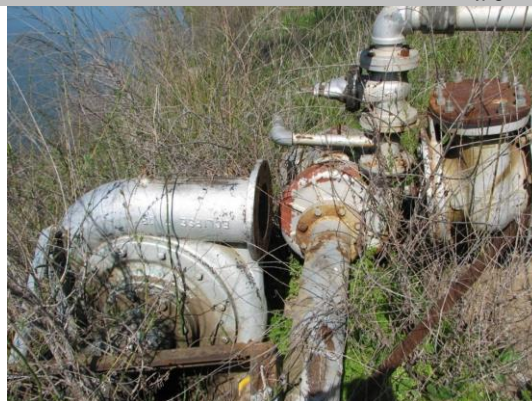
Photo 2 of 3 : UCIP_FA_2018_43459_36795.jpg

Pump located on waterward side is not connected.

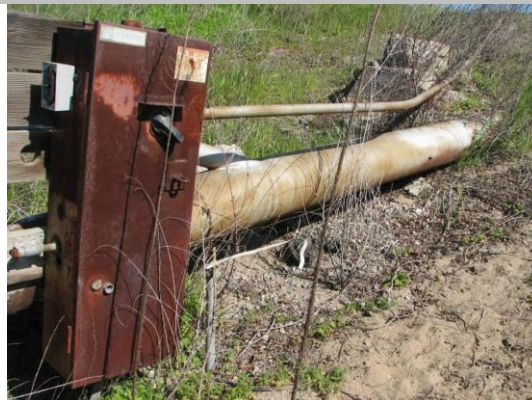
Photo 3 of 3 : UCIP_FA_2018_43459_36797.jpg

Comment Code						
Inspector Comment						
FS_ID:43459 DS_ID:24185 EP_NO: N/A Repair Type: Non-Urgent Crossing Status: Found UCIP Comments: No connection present--need to contact owner to determine if owner plans to use. If crossing is no longer in use owner will need to coordinate with DWR inspector and CVFPB to remove according to Title 23 requirements. Recommend removing vegetation along pipe alignment. Note date on photos should be 3/18/09 not 7/26/08 camera metadata is incorrect. FIELD_STRUCT_DESC: *ABANDONED* 10-inch steel irrigation pipe and 2-inch electrical conduit through the levee, both 2.8 feet below the levee crown. Abandoned pumps and gate valve on the waterside (WS) slope. Service pole on the landside (LS) slope. Concrete headwall on LS. [Additional Reference(s): DWR Levee Log, 2005. USACE Sacramento O&M Manual Unit No. 110, May 1959, revised 29 Dec 2016, (HLM 4.8)] FS Date: 3/19/2009

Pipe on waterward side.

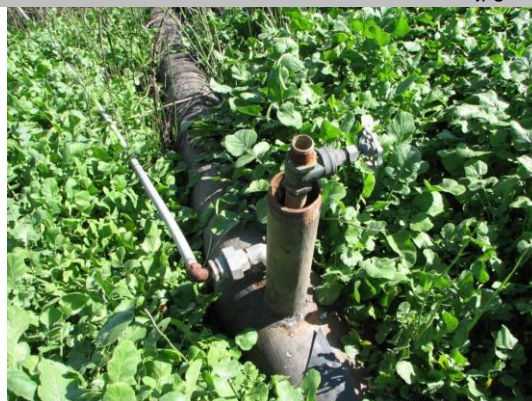
Photo 1 of 3 : UCIP_FA_2018_43431_36800.jpg

Comment Code					
Inspector Comment					
FS_ID:43431 DS_ID:24186 EP_NO: 15359 Repair Type: Non-Urgent Crossing Status: Found UCIP Comments: Dense vegetation limits the inspector's visibility to identify signs of pipe failure (leaks) through the levee slopes. Recommend removing vegetation along pipe alignment to conduct proper inspection of structure and appurtenances. Note date on photos should be 3/18/09 not 7/26/08 camera metadata is incorrect. FIELD_STRUCT_DESC: 10-inch steel irrigation pipe sleeved through a 12-inch conductor pipe through the levee, 6.0 feet below the levee crown. Siphon breaker in protective house at levee shoulder. Pump in pump house and power pole at landside (LS) toe. Pipe connected to 8-inch exposed pipe at LS shoulder, extending to pump house. Filter screen in channel at waterside (WS) toe. (existing 4-inch pipe removed and new 10-inch sleeved through 12-inch installed under Permit No. 15359, 1990 - E. Delta Orchards) [Additional Reference(s): DWR Levee Log, 2005] FS Date: 3/19/2009

Air vent located on pipe on landward.

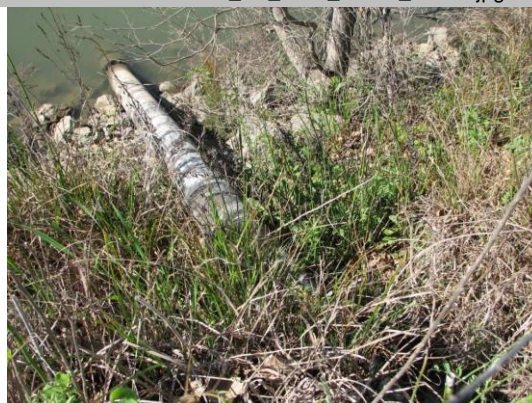
Photo 2 of 3 : UCIP_FA_2018_43431_36801.jpg

Pipe located on waterward side.

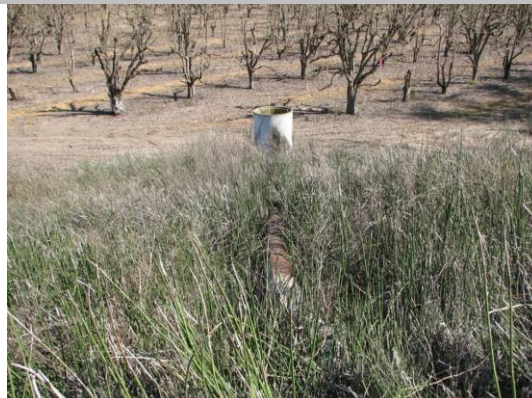
Photo 1 of 2 : UCIP_FA_2018_43433_70484.jpg

Comment Code					
Inspector Comment					
FS_ID:43433 DS_ID:24188 EP_NO: N/A Repair Type: Non-Urgent Crossing Status: Found UCIP Comments: Walkway is no longer functional. Need to contact owner--if crossing is no longer used owner will need to coordinate with DWR Inspector and CVFPB. Dense vegetation limits the inspector's visibility to identify signs of pipe failure (leaks) through the levee slopes. Recommend removing vegetation along pipe alignment to conduct proper inspection of structure and appurtenances. Note date on photos should be 3/18/09 not 7/26/08 camera metadata is incorrect. FIELD_STRUCT_DESC: 12-inch irrigation pipe of unknown material through the levee, 6.2 feet below the crown. Pump and control panel on piling structure in stream, with walkway. Service pole and concrete standpipe on the landside (LS) slope. [Additional Reference(s): DWR Levee Log, 2005. USACE Sacramento O&M Manual Unit No. 110, May 1959, revised 29 Dec 2016, (HLM 5.5)] FS Date: 3/19/2009

View of landward side--pipe and stand pipe visible.

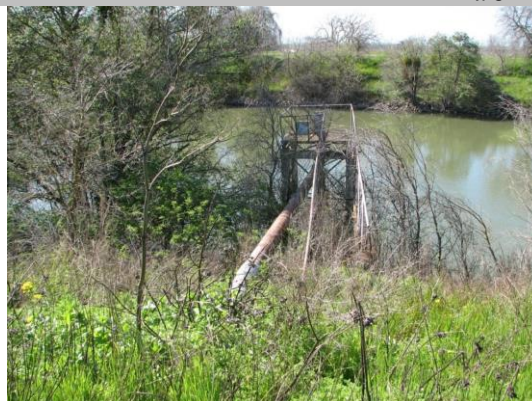
Photo 2 of 2 : UCIP_FA_2018_43433_70483.jpg

View of waterward side--pipe and remaining appurtenances.
